**Region 9 Enforcement and Compliance Assurance Division  
COMPLIANCE EVALUATION INSPECTION REPORT**

<b>Inspection Date(s):</b>	August 9, 2022	<b>Inspection Announced:</b> No	
<b>Time:</b>	<b>Entry:</b> 10:00 AM	<b>Exit:</b> 11:00 AM	
<b>Media:</b>	Safe Drinking Water Act		
<b>Regulatory Program(s)</b>	Underground Injection Control		
<b>Company Name:</b> Acton Holding Trust			
<b>Facility or Site Name:</b> Cactus Creek Mobile Home Park			
<b>Facility Location(s):</b> 3740 Smith Ave			
<b>(city, state, zip code)</b> Acton, CA 93510			
<b>Mailing Address:</b> 17100 Bear Valley Rd Ste B			
<b>(city, state, zip code)</b> Victorville, CA 92395			
<b>County:</b> Los Angeles County			
<b>Facility/Site Contact(s)</b>		The Acton Holding Trust	willdu03@yahoo.com
		Bill Trolinger, Site Manager	661-526-4411
<b>Facility/Site Identifier:</b> Parcel No. 3208-026-048			
<b>Inspector(s):</b>			
Maureen Munoz (author)	Signature and Date:		
	ECAD-3-3	Inspector	415-972-3782
Christopher Chen	Signature and Date:		
	ECAD-3-3	Inspector	213-244-1853

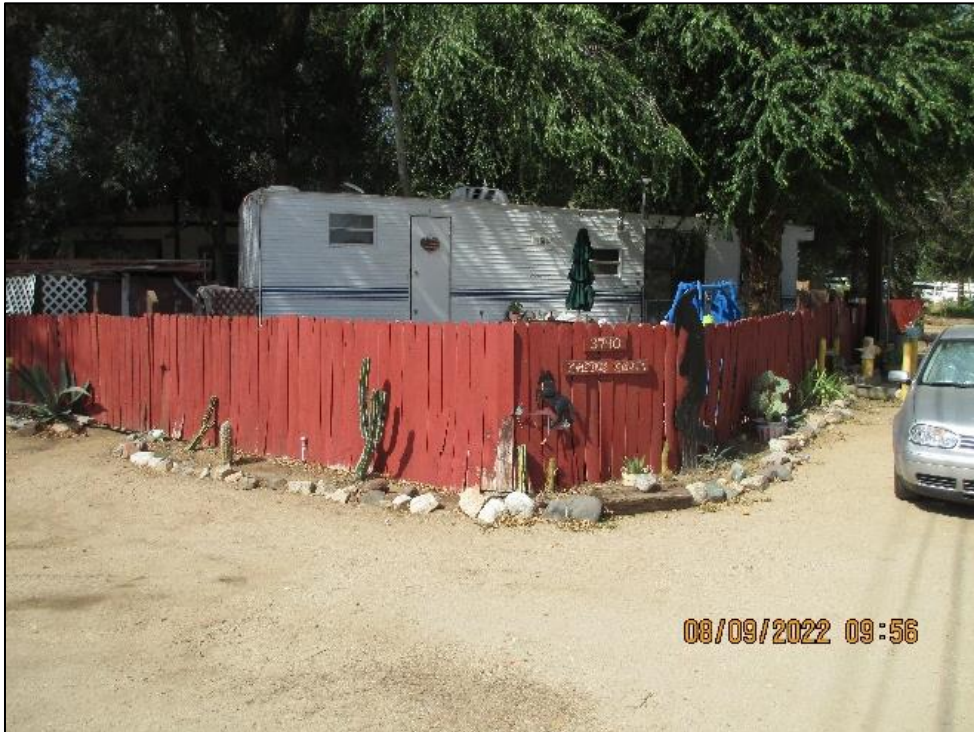
**Image 1:** Front of the mobile home park. Includes the street number and mobile home park name.

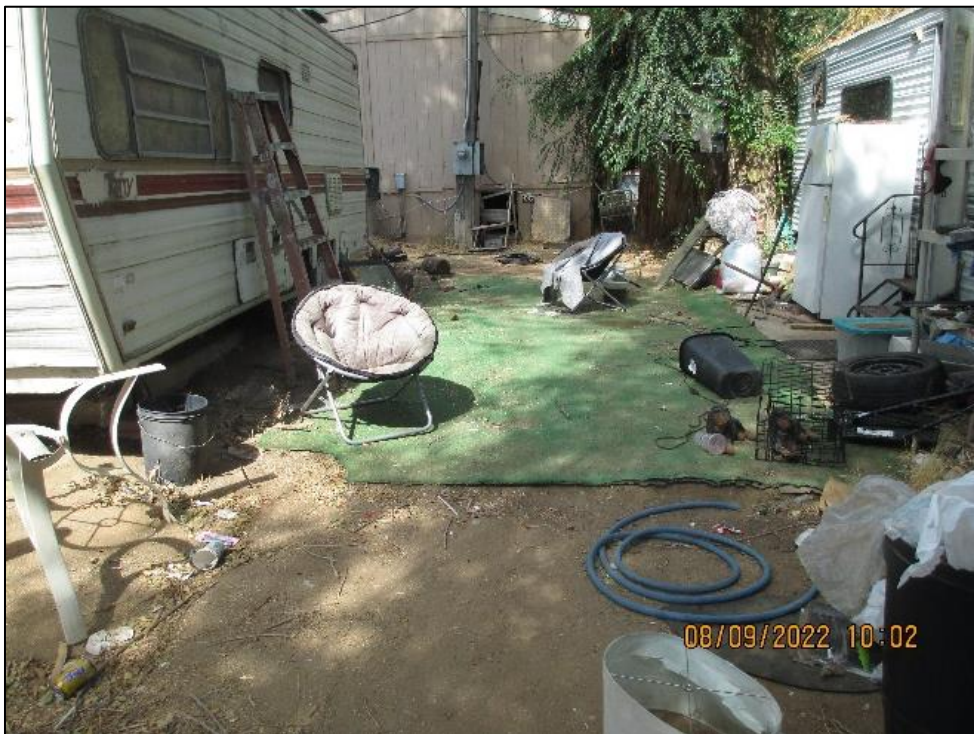
**Image 2:** Two mobile homes located at the southeast end of the Property.

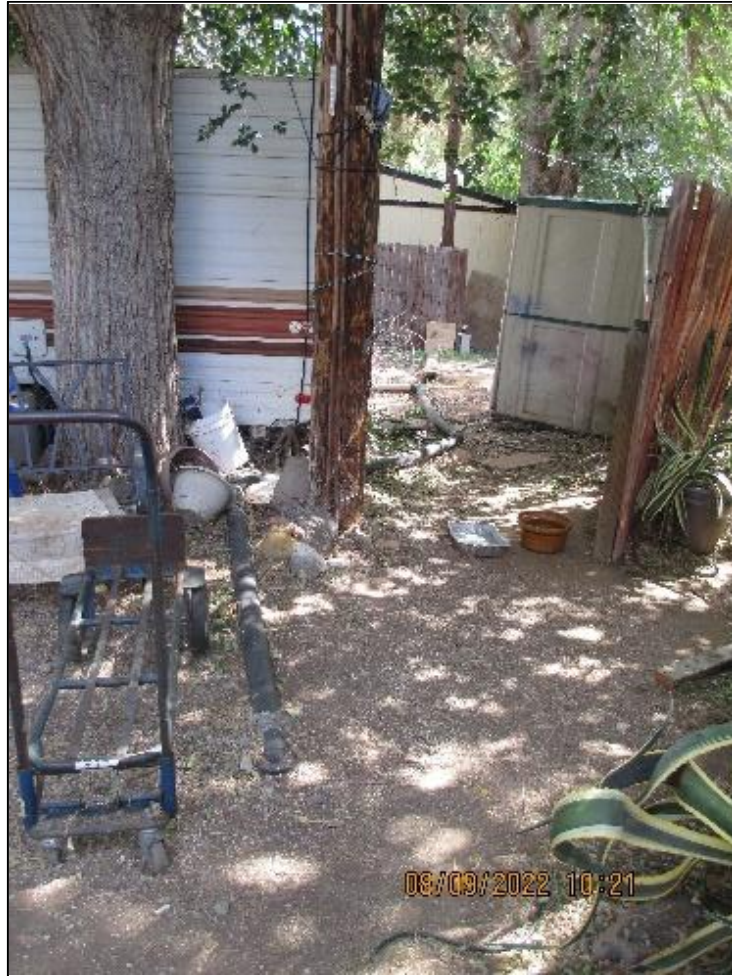
- We observed above-surface black piping that was located near the southwest mobile homes that traced along the outside of the mobile homes and continued under a large pile of debris covered by a black tarp (Image 3 and 7). We were unable to observe where the pipes led to due to the pile of debris. Although the piping was near the West Cesspool (Image 6), the pipes did not appear to connect to either of the cesspools.

**Image 3:** Black above-surface pipeline between two mobile homes on the southwest side of the Park.

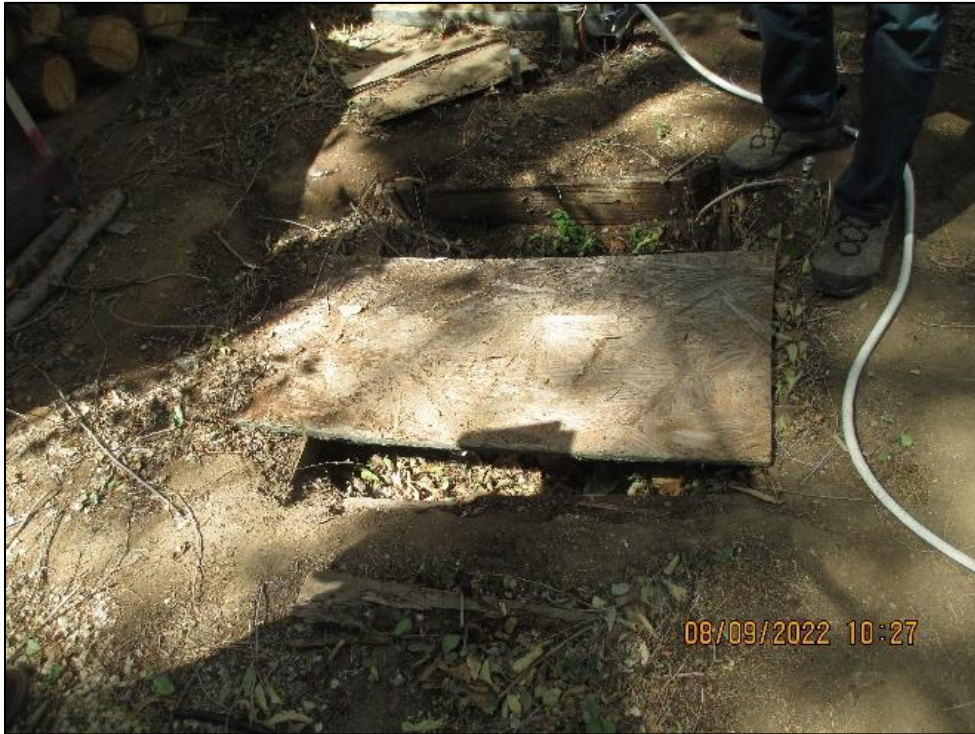
- One cesspool (hereafter called “West Cesspool”) was located on the westside of the Property (Images 4-6). We did not observe clearly associated unit numbers for the homes. Roughly, this cesspool was located next to the southwest mobile homes. The mobile home it was located next to had no fencing and was the second-most southwest mobile home on the Property.

The West Cesspool was located within a shallow, rectangular hole that was covered by a loose plywood cover (Image 4). The cesspool itself was secured with a faded green plastic lid (Image 5). Red bricks were placed atop the cesspool lid. Spider webs and branches were scattered in the rectangular hole. The dirt area surrounding the cesspool was damp. We did not detect any pungent smells. One potable water faucet with a white hose was located next to the cesspool (Image 6).

**Image 4:** Unsecure plywood cover placed above West Cesspool.

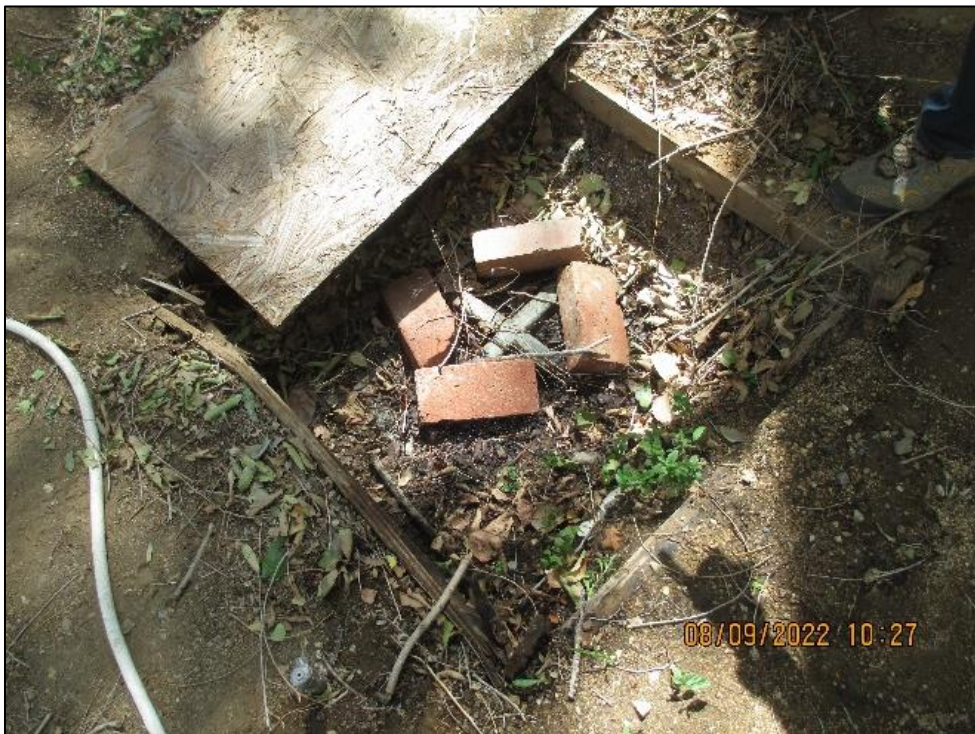
**Image 5:** West Cesspool cover had red bricks on top. White hose located on the left of the image is connected to potable water faucet.

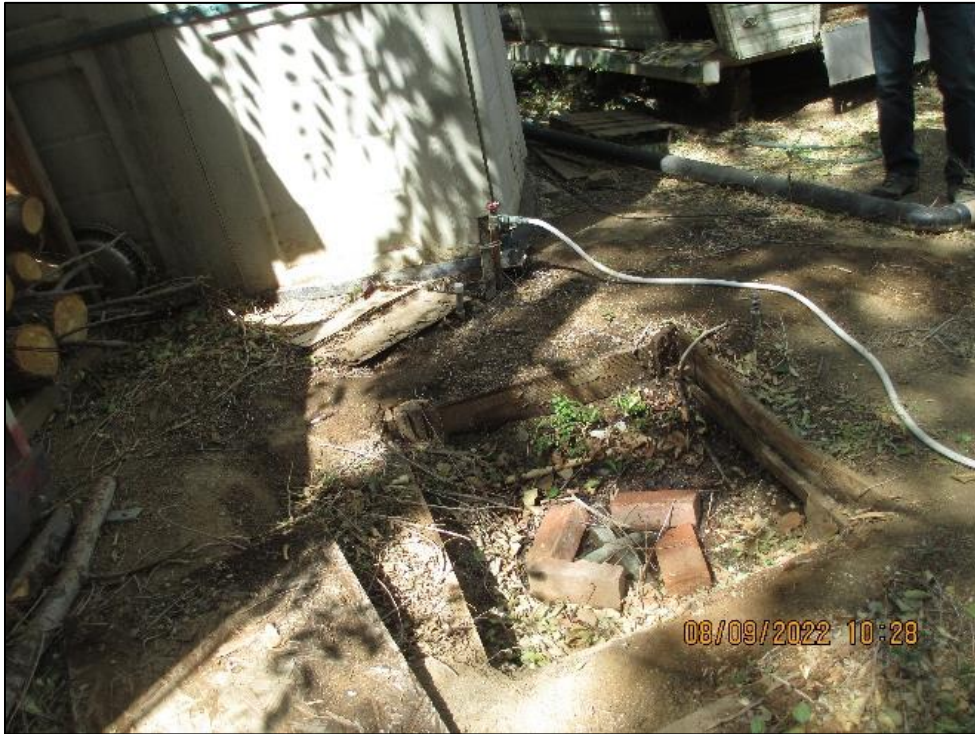
**Image 6:** Another angle of West Cesspool. white hose, and potable water line as pictured/referenced in Image 5.

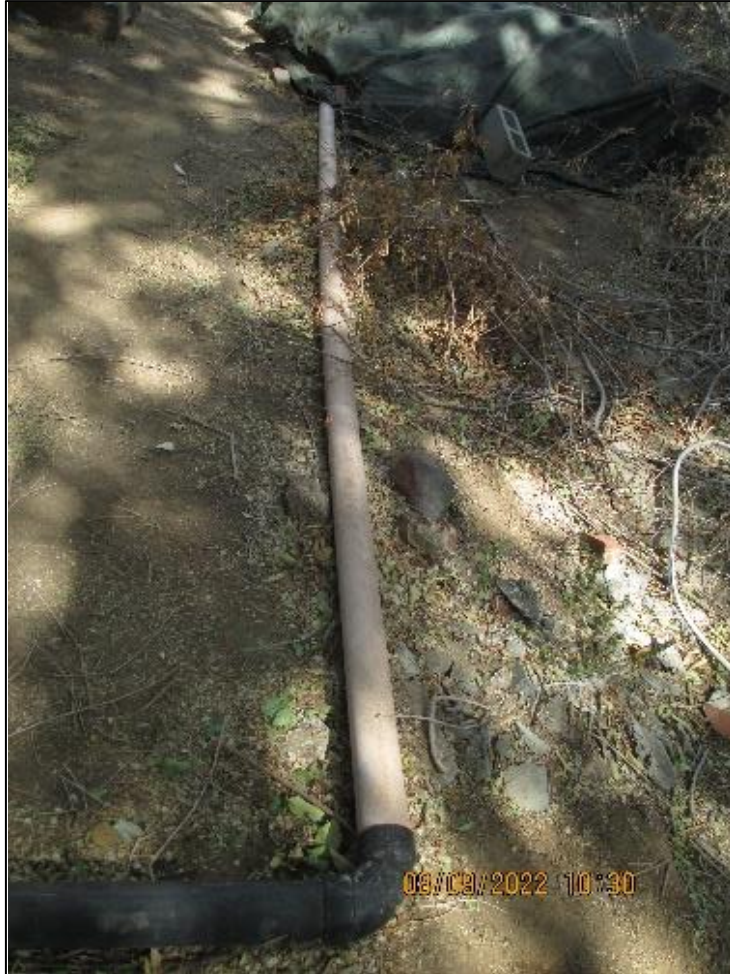
**Image 7:** Pipeline connected to the pipes pictured in Image 3. Continued under covered debris pile.

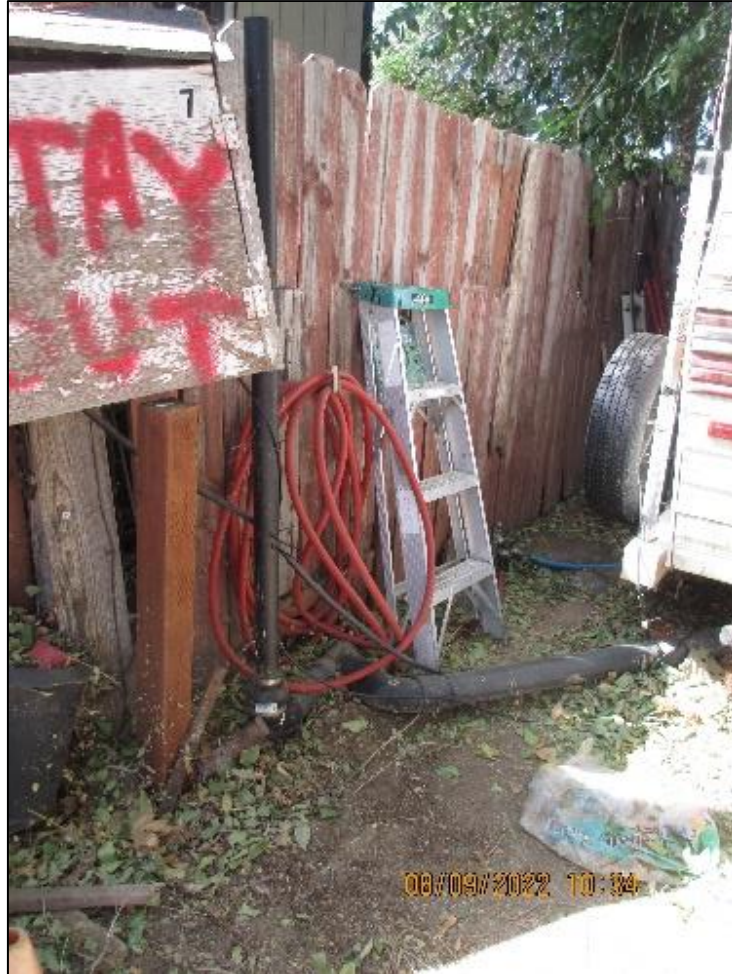
- We observed above-surface black pipes with a vent located near a mobile home located towards the middle east side of the Property (Image 8). We were unable to identify where the piping connected to.

**Image 8:** Black pipe and vent connected to a mobile home.

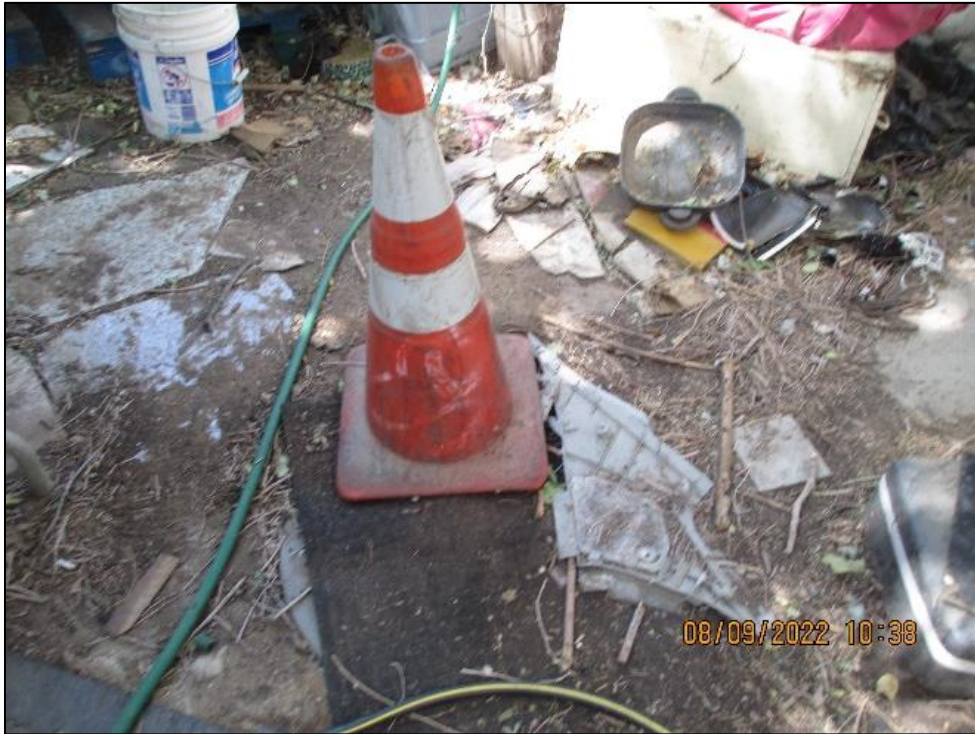
- A second cesspool (“East Cesspool”) was located on the eastside of the Property in a mobile home’s yard (Image 9 and 10). This mobile home was located behind the red fencing with a red wooden gate located along 3<sup>rd</sup> street (Image 11). The cesspool was covered by a black house mat and a large orange traffic cone (Image 9). East Cesspool was secured by a faded green plastic lid with a cross-sectional pattern (Image 10), similar to the lid securing West Cesspool. The dirt covering East Cesspool was damp. One potable water faucet with a green hose was located next to the cesspool (Image 10).

**Image 9:** East Cesspool was located under traffic cone and black house mat. Green hose connected to potable water faucet pictured on the left.

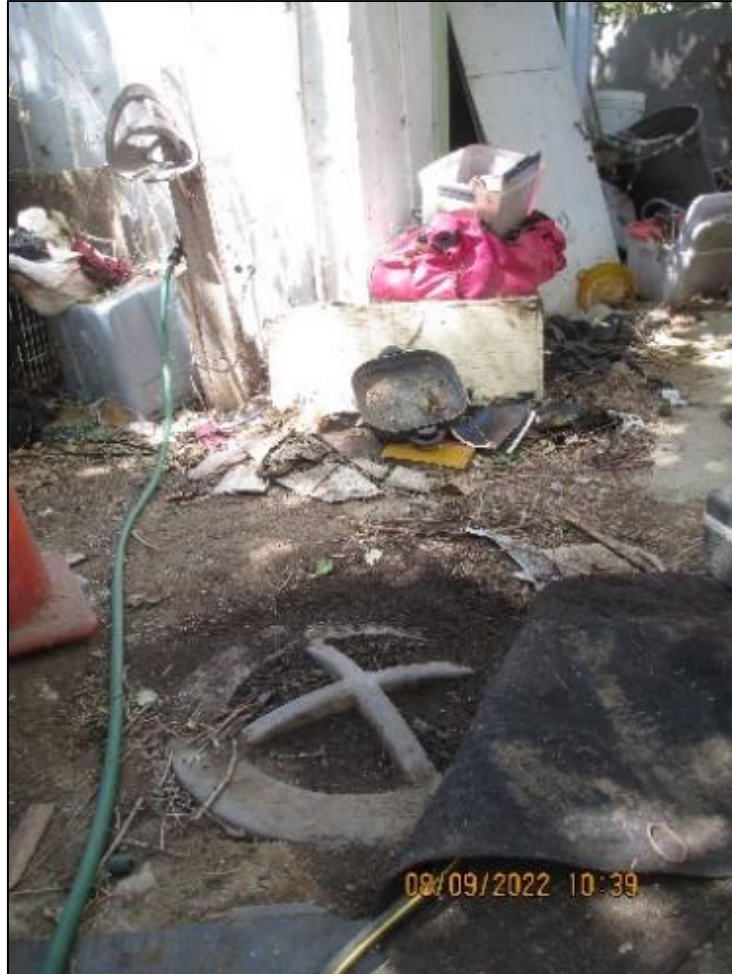
**Image 10:** East cesspool cover. Green hose and potable water faucet located west of cesspool.

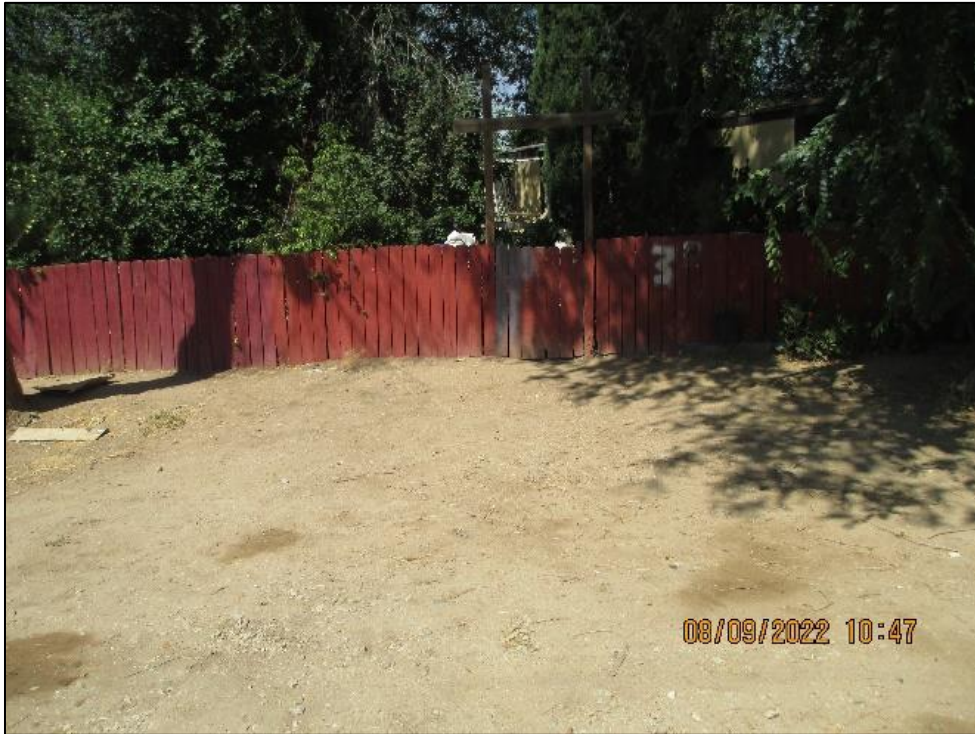
**Image 11:** Red fence located on the eastside of the Property, facing 3<sup>rd</sup> St. East Cesspool was located behind the fence.

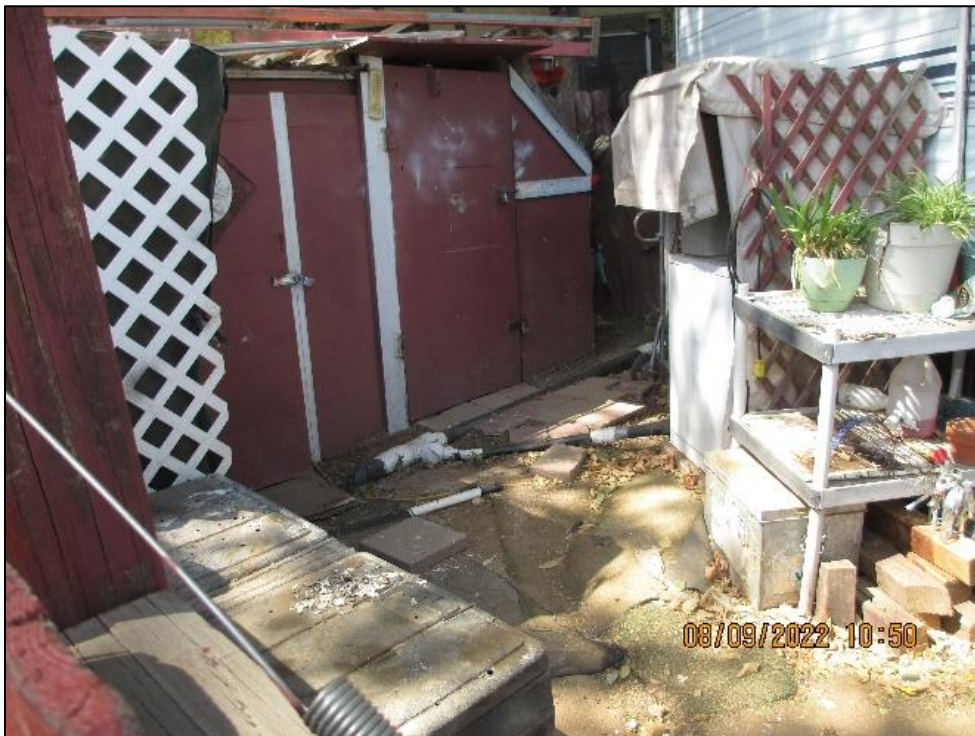
- We observed above-surface black pipes that connected to a washer and dryer located outside one of the northeastward mobile homes, and the piping branched off towards the back of the mobile home (Image 12). We were unable to identify where the rest of the piping connected. The black piping connected to a pipe that led to an open discharge point pointed towards 3<sup>rd</sup> Street (Image 13).

**Image 12:** Black pipes connected to washer and dryer and branches off behind the mobile home. Appeared to connect to the pipe pictured in Image 13.

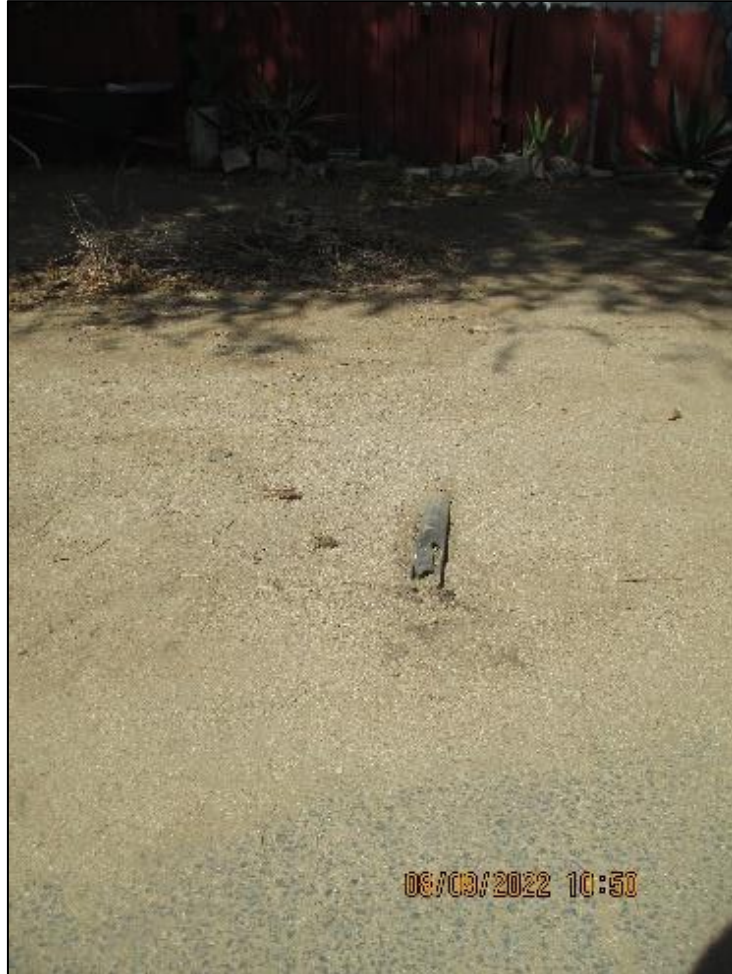
**Image 13:** Open black pipe protruding from ground. Appeared to connect to black pipes in Image 12.
